# FACILITY COMPLIANCE INSPECTION REPORT

## Division of Waste Management Solid Waste Section

Lined MSWLF		LCID		YW		Transfer		Compost		SLAS	<b>X</b>	<b>COUNTY:</b> Lincoln <b>PERMIT NO.:</b> SLAS-55-01 <b>FILE TYPE:</b> COMPLIANCE
Closed MSWLF		HHW		White goods		Incineration		T&P		FIRM		
CDLF		Tire T&P / Collection		Tire Monofill		Industrial Landfill		DEMO		SDTF

Dennis Hoyle Services  
7337 Reeps Grove Church Rd.  
Vale, NC 28168

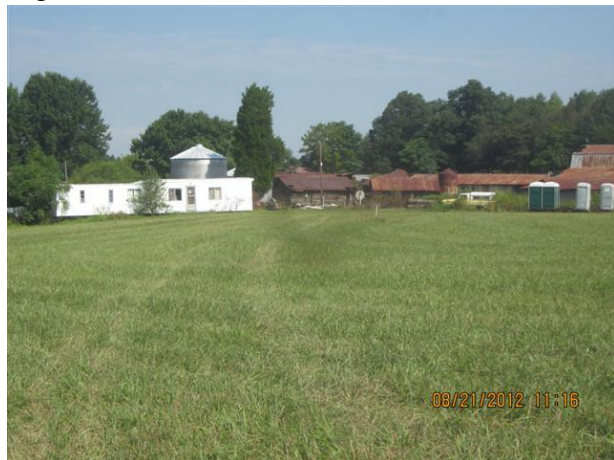
10. The cover crop on both fields had been recently cut. (Photos #1 and #2)
11. The nutrient management plan stipulates that both fields are to be cut *"whenever it reaches 12 inches in height or just before seedhead [sic] emergence"*.

1. Looking (N) from the center of Field #1 back towards the entrance to the field.

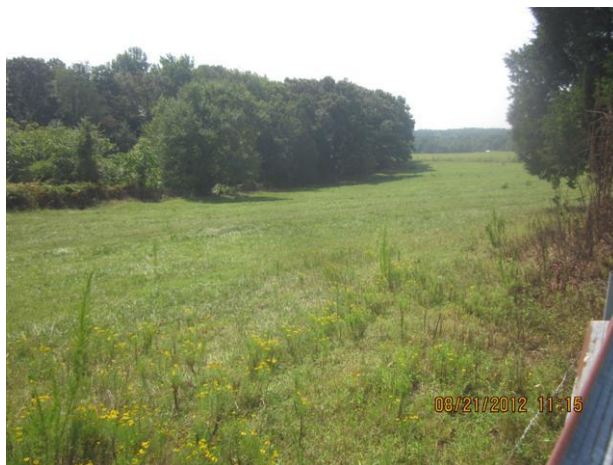
2. Looking (S), from the entrance gate, down the length of Field #2.
